**Steam Incident Investigation at
East 41st Street and Lexington Avenue
New York, NY**

**July 18, 2007 Steam Incident Investigation
At East 41st Street and Lexington Avenue
New York, NY.**

Report No. 1763931-R-001

ABSG Consulting, Inc. (ABS Consulting)
Northeast Area Office
118 Portsmouth Avenue
Stratham, NH 03885

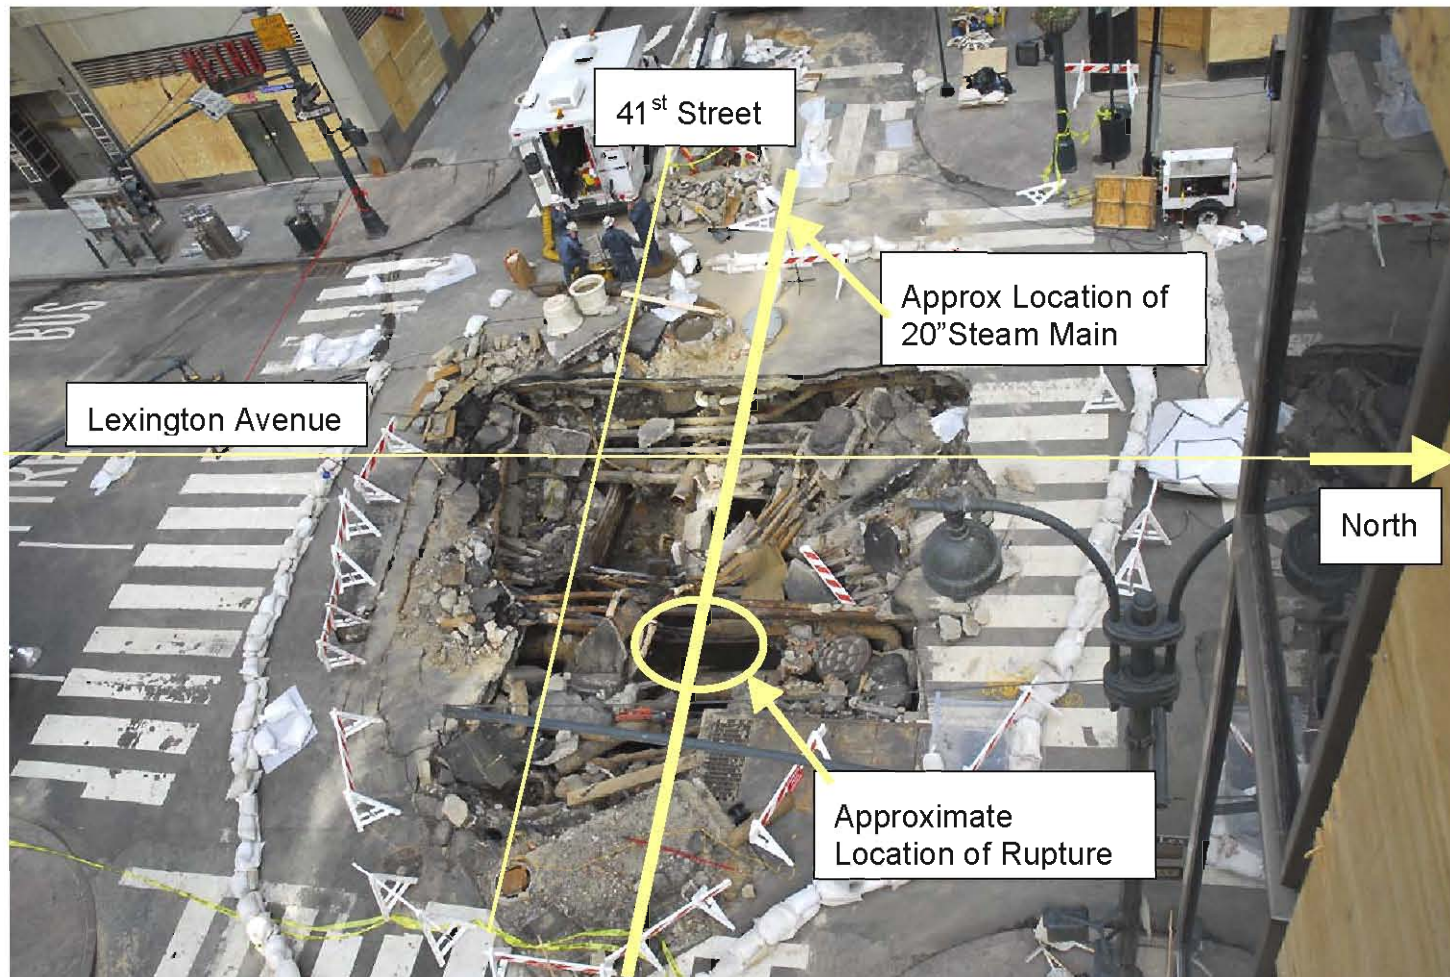
Figure 1-3: Image of Crater During Debris Removal

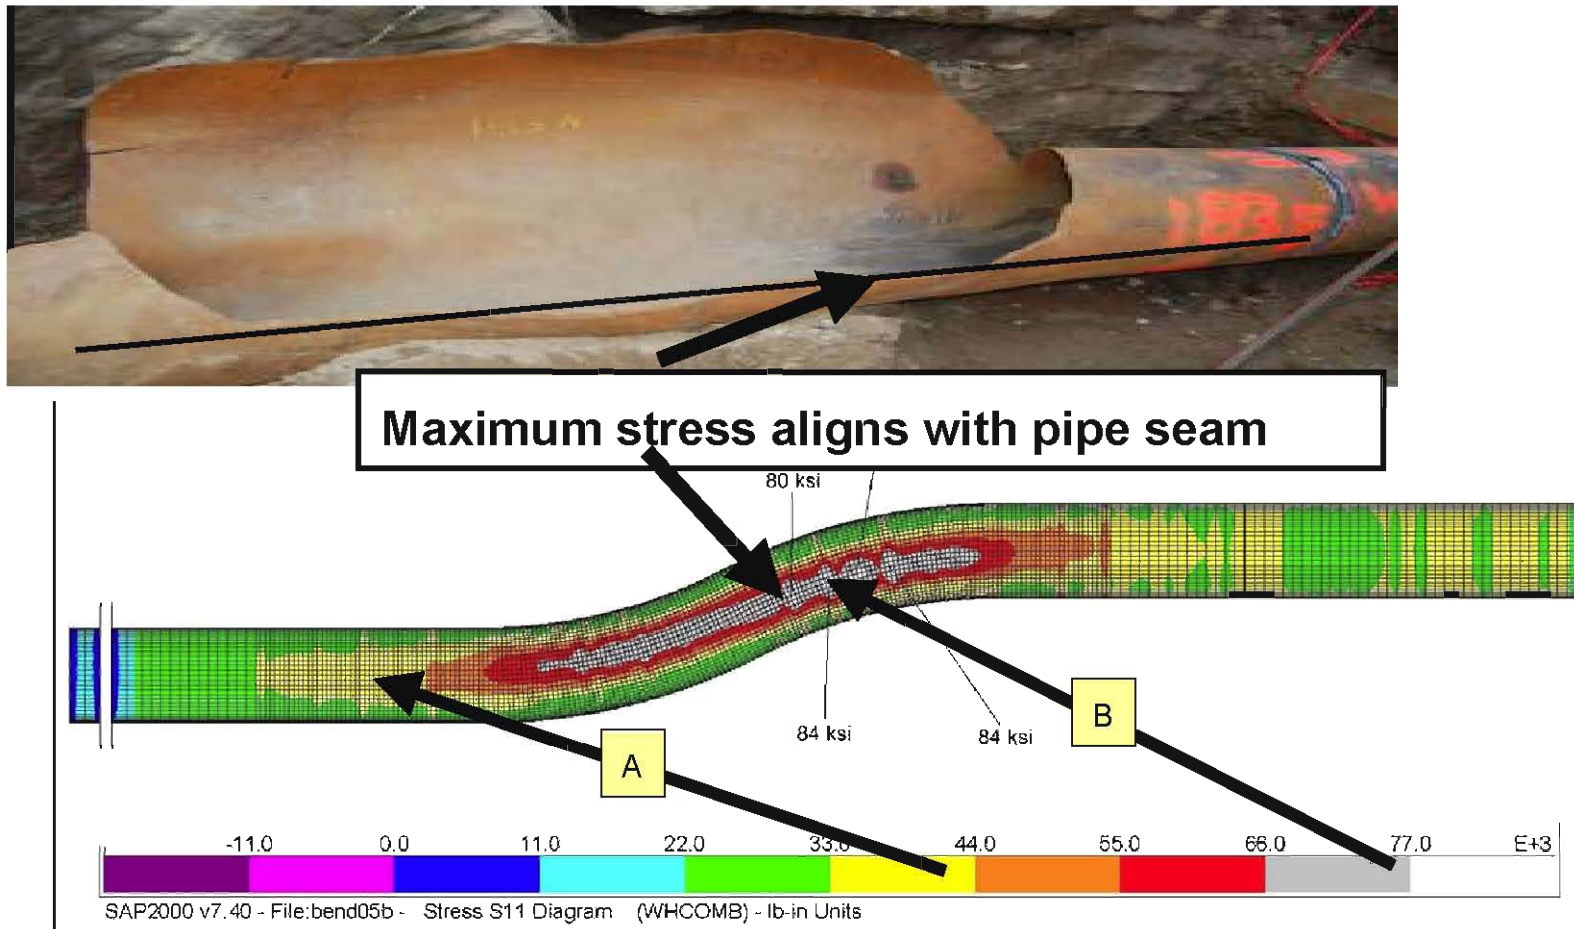
Figure 3-7: Maximum Pipe Stresses

(Stress levels in the horizontal west end of File 3 bend (Pt A above) can be seen to be significantly lower in stress magnitude than in the bend region, (Pt B above)).

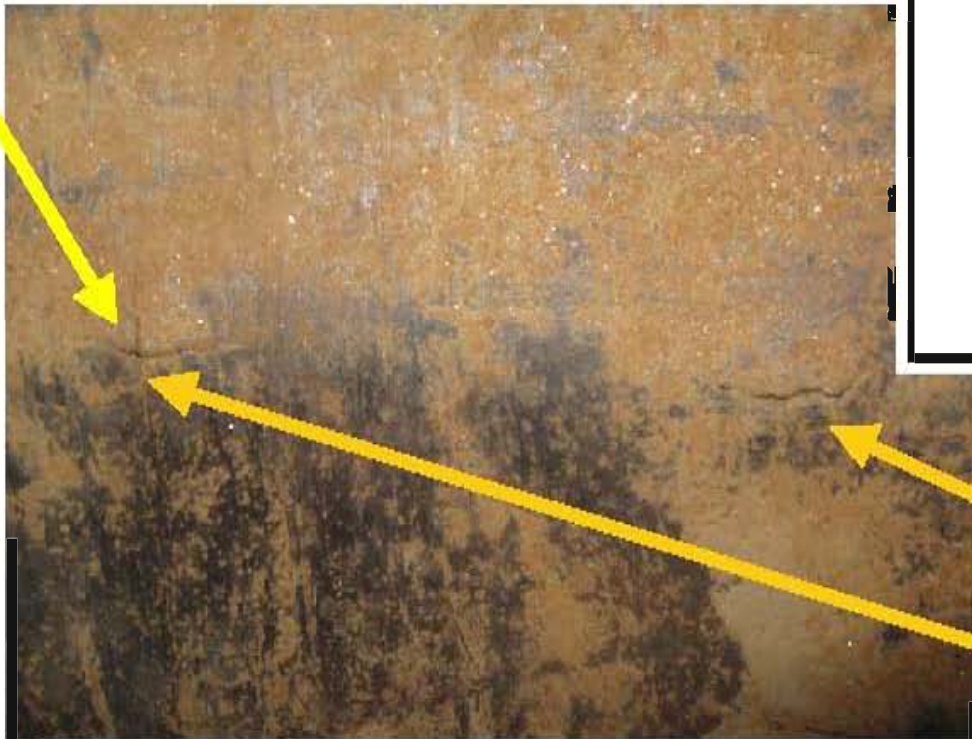
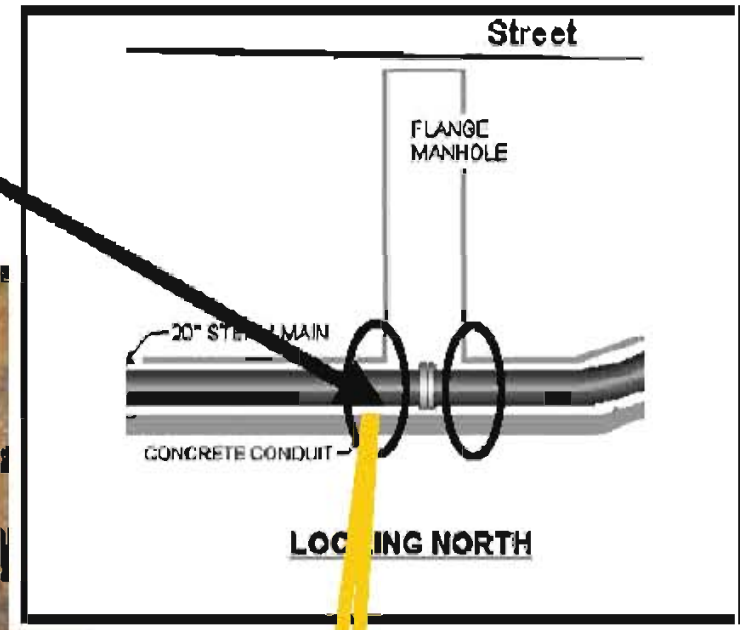
An assessment was performed to determine the impact of pipe deflection in a vertical direction at the File 3 bend, with roller supports located at the flange manhole (at the indentation points). This assessment was performed to investigate the potential causes of the observed indentations in the pipe. A deflection of the pipe could occur from the section across Lexington being full of condensate or from a waterhammer loading at the File 3 bend. The calculated pipe stresses due to the weight of water filling the pipe would be insufficient to create the observed indentations. Pipe stresses at the roller support locations, from waterhammer load deflection at the File 3 bend could result in formation of these indentations.

With consideration of this loading, it is concluded that a prior waterhammer event of insufficient magnitude to burst the pipe likely occurred at the Incident Site prior to the March 2005 weld repair.

LOCATION WHERE INDENTATION
HAD PREVIOUSLY BEEN WELD
REPAIRED

Figure 3-8: Interior View of Indentations Adjacent to Flange Section

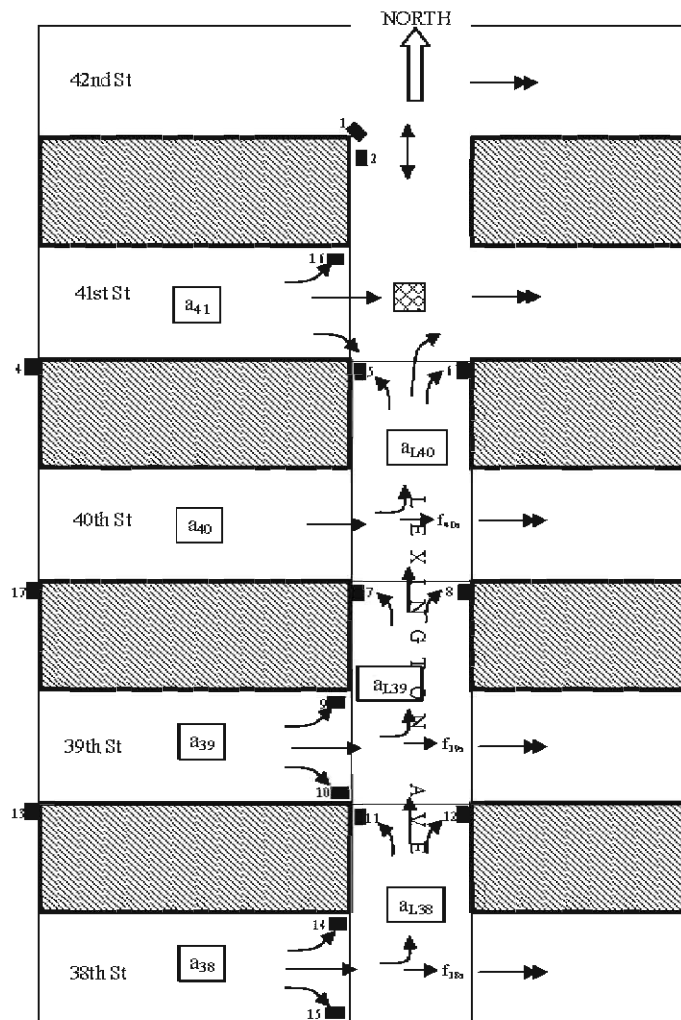
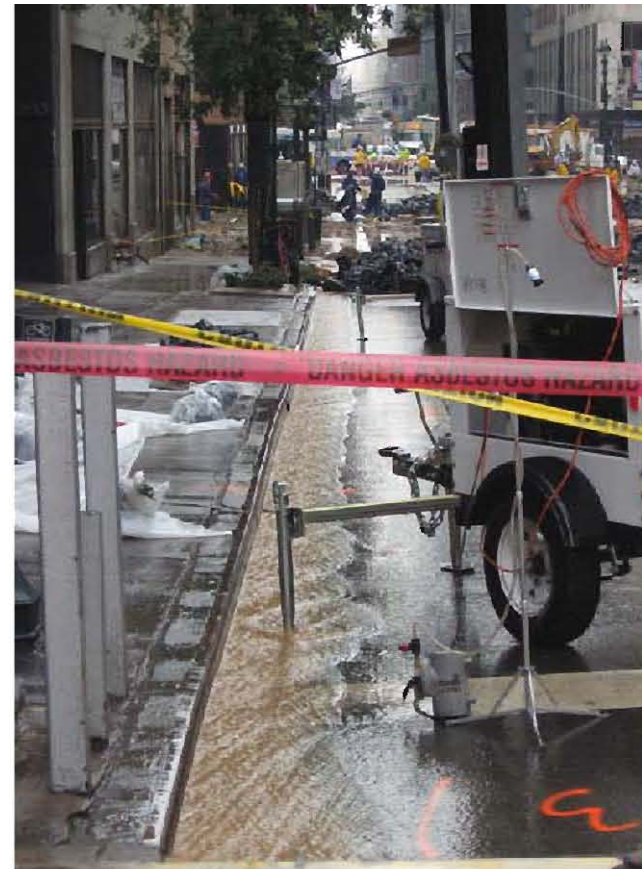
Figure 4-1: Street Drainage and View East on 41st Street

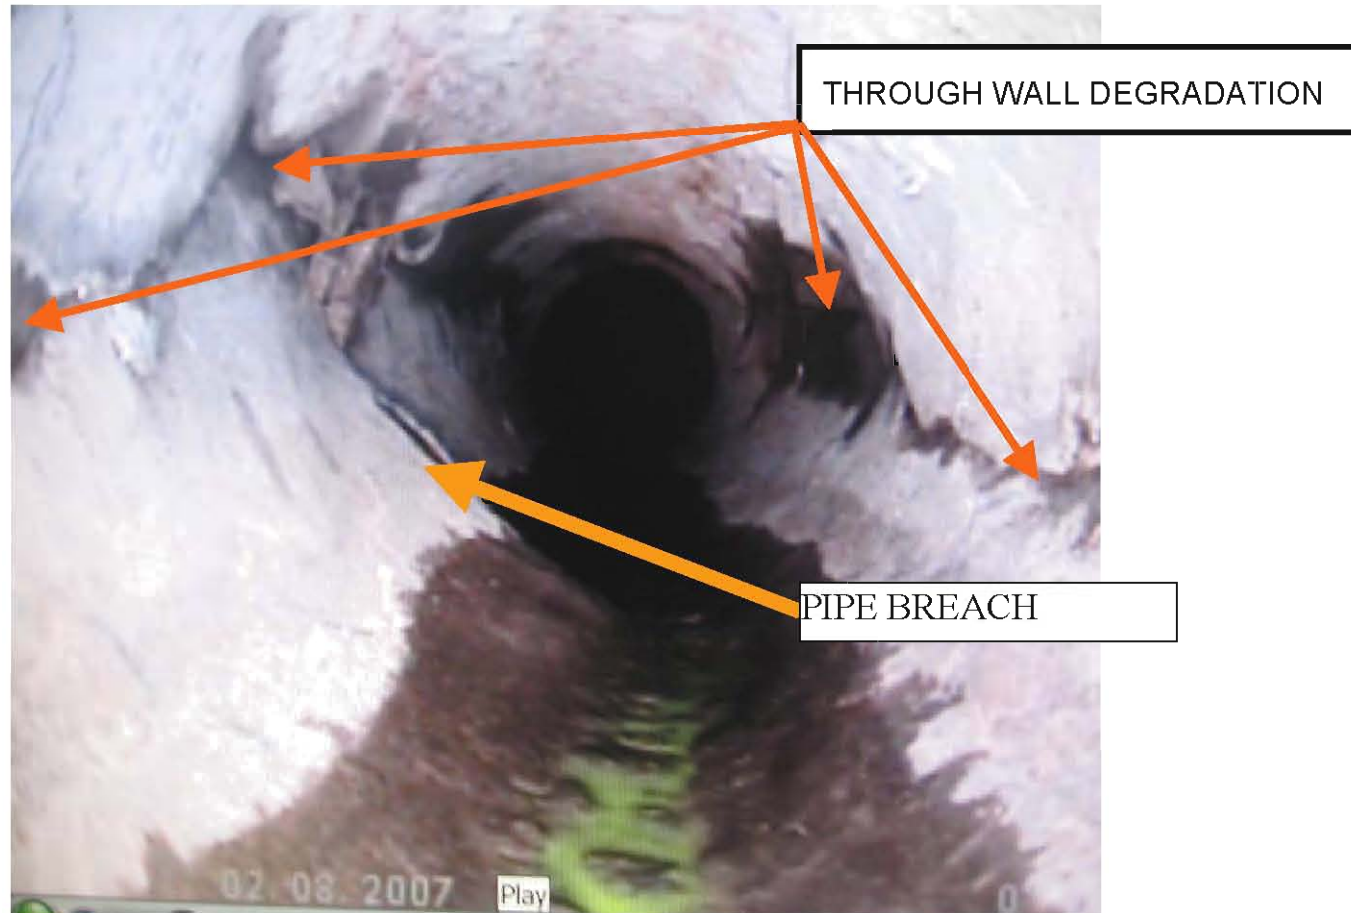
Floodwater sources were investigated and potential sources were identified as: 1) direct infiltration from the adjacent northwest catch basin; 2) potential pressurization from the local sewers running full under heavy rain conditions, and ; 3) potential leakage from a water main.

Figure 4-5: Northwest Catch Basin to Clean-out

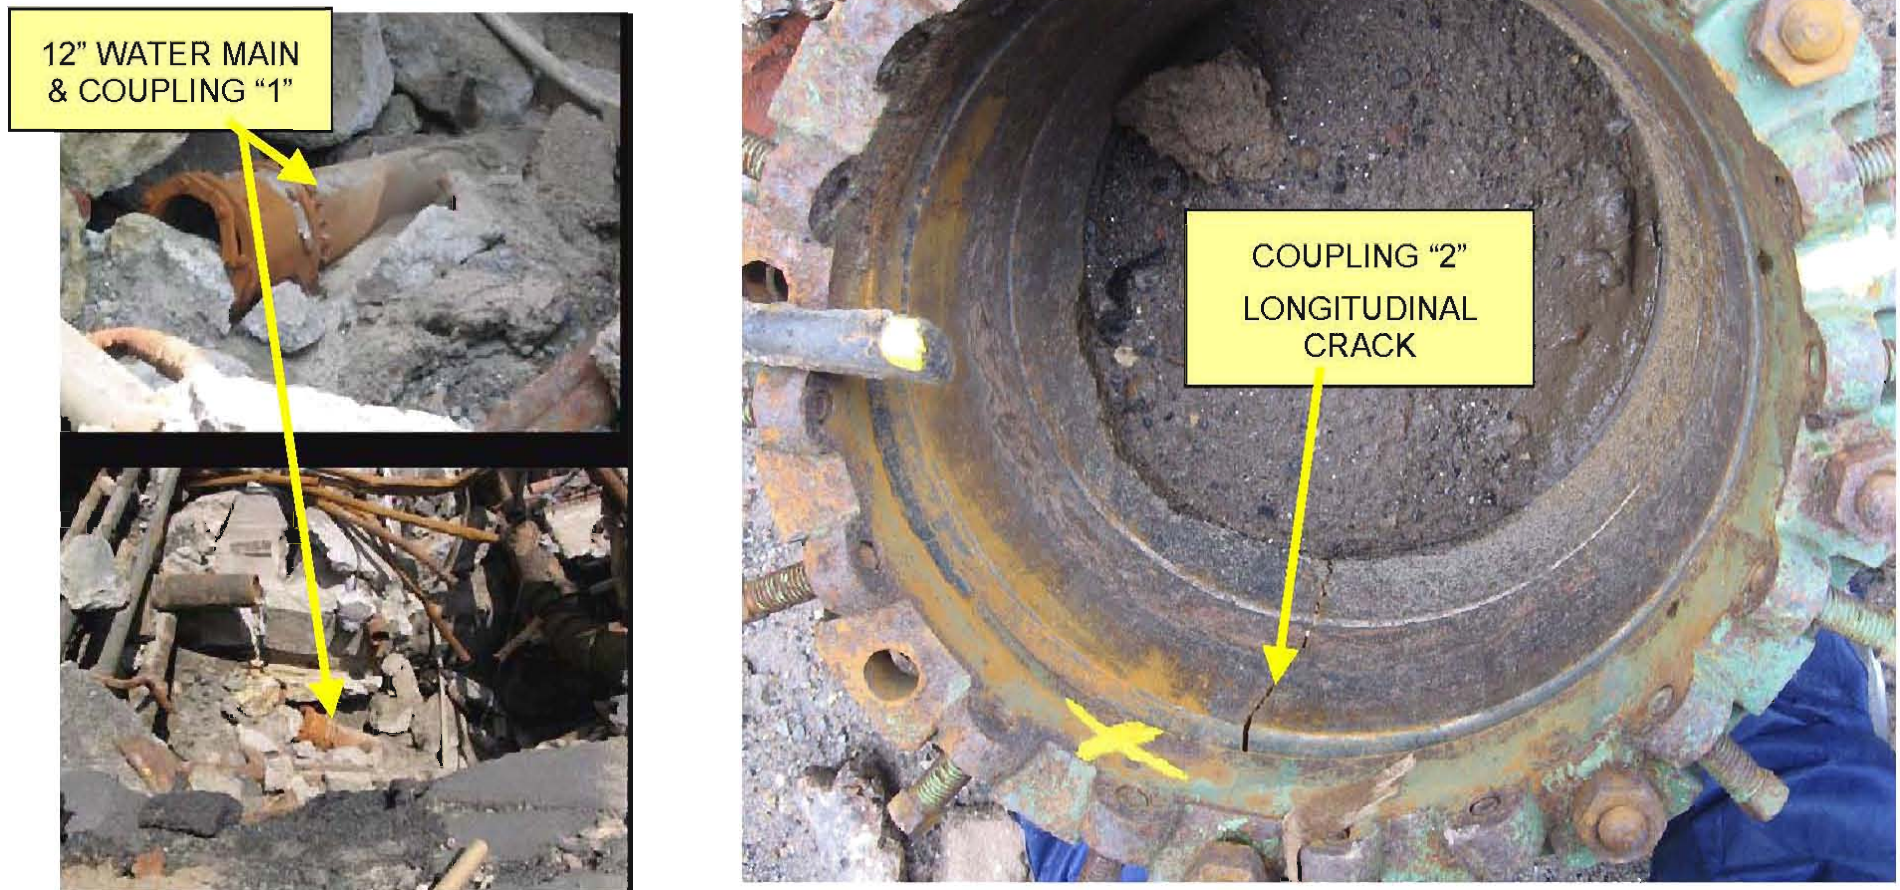
Figure 4-6: 12" Diameter Water Main and Coupling in Crater and A Cracked Coupling Removed from Crater
(Coupling "1" is visible left, and Coupling "2", has a longitudinal crack visible in the coupling (picture on right))

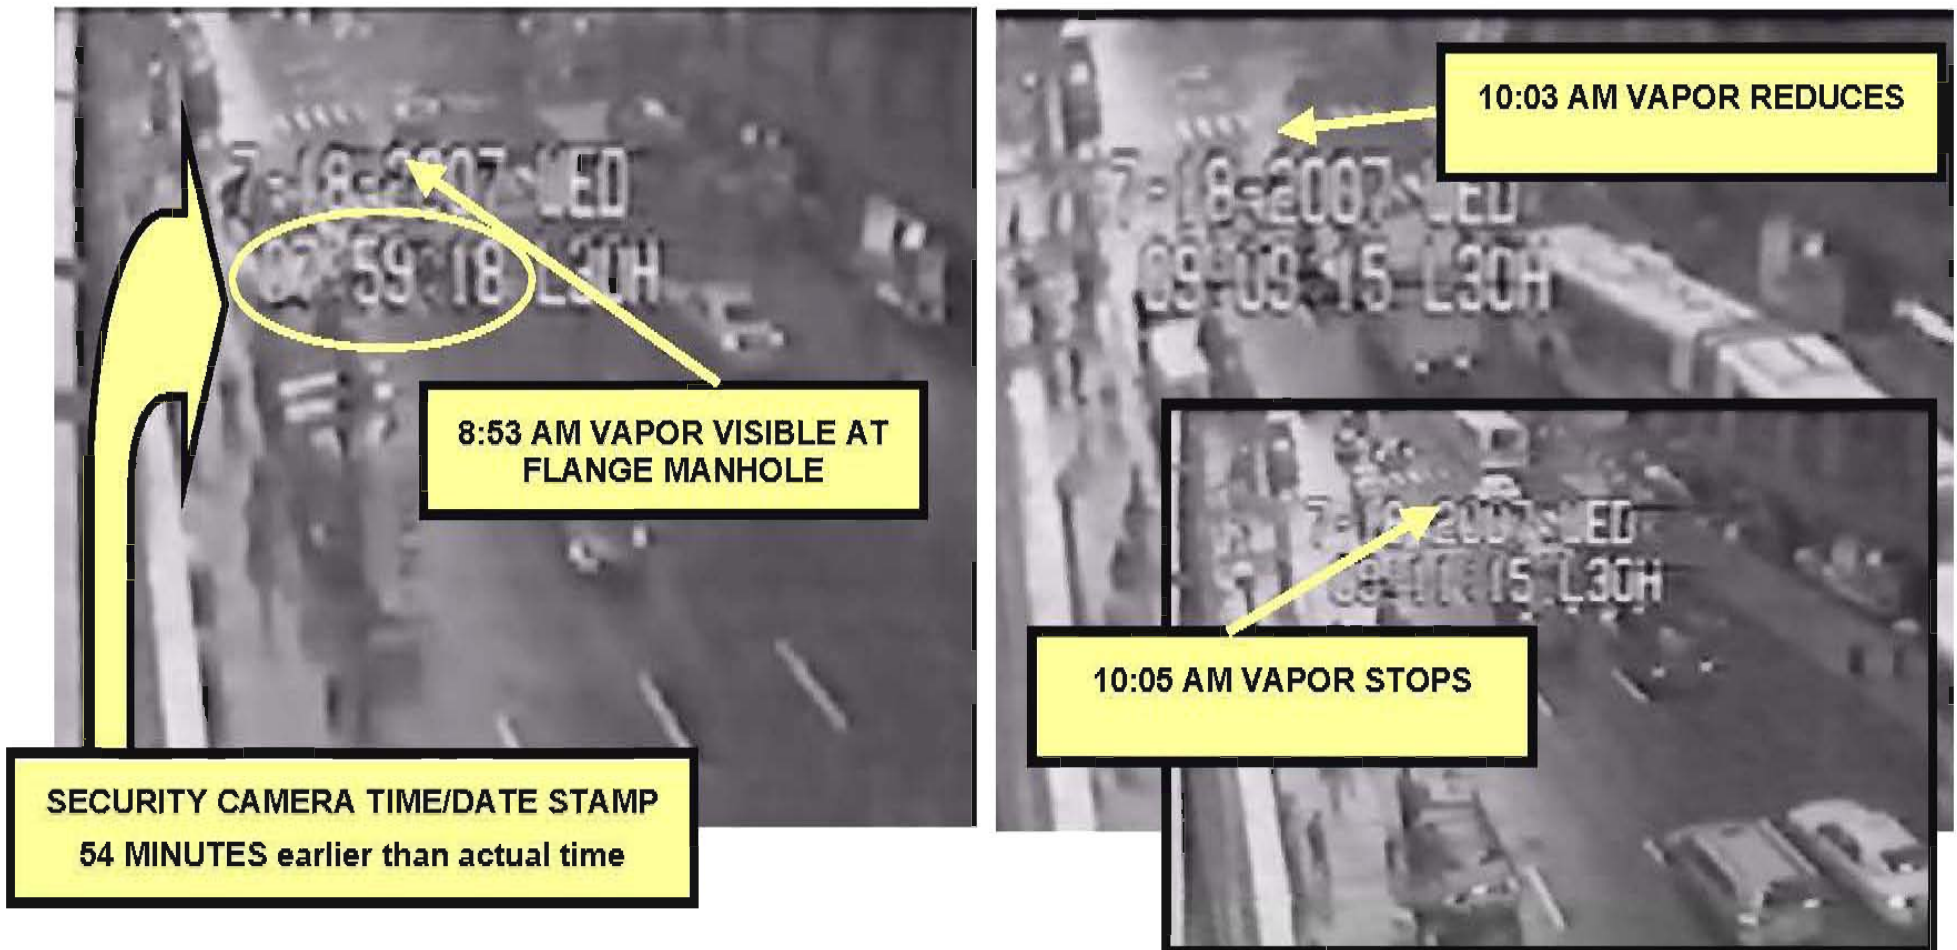
Figure 4-8: Start and End of Observable Vapor From Flange Manhole – Security Camera Looking South

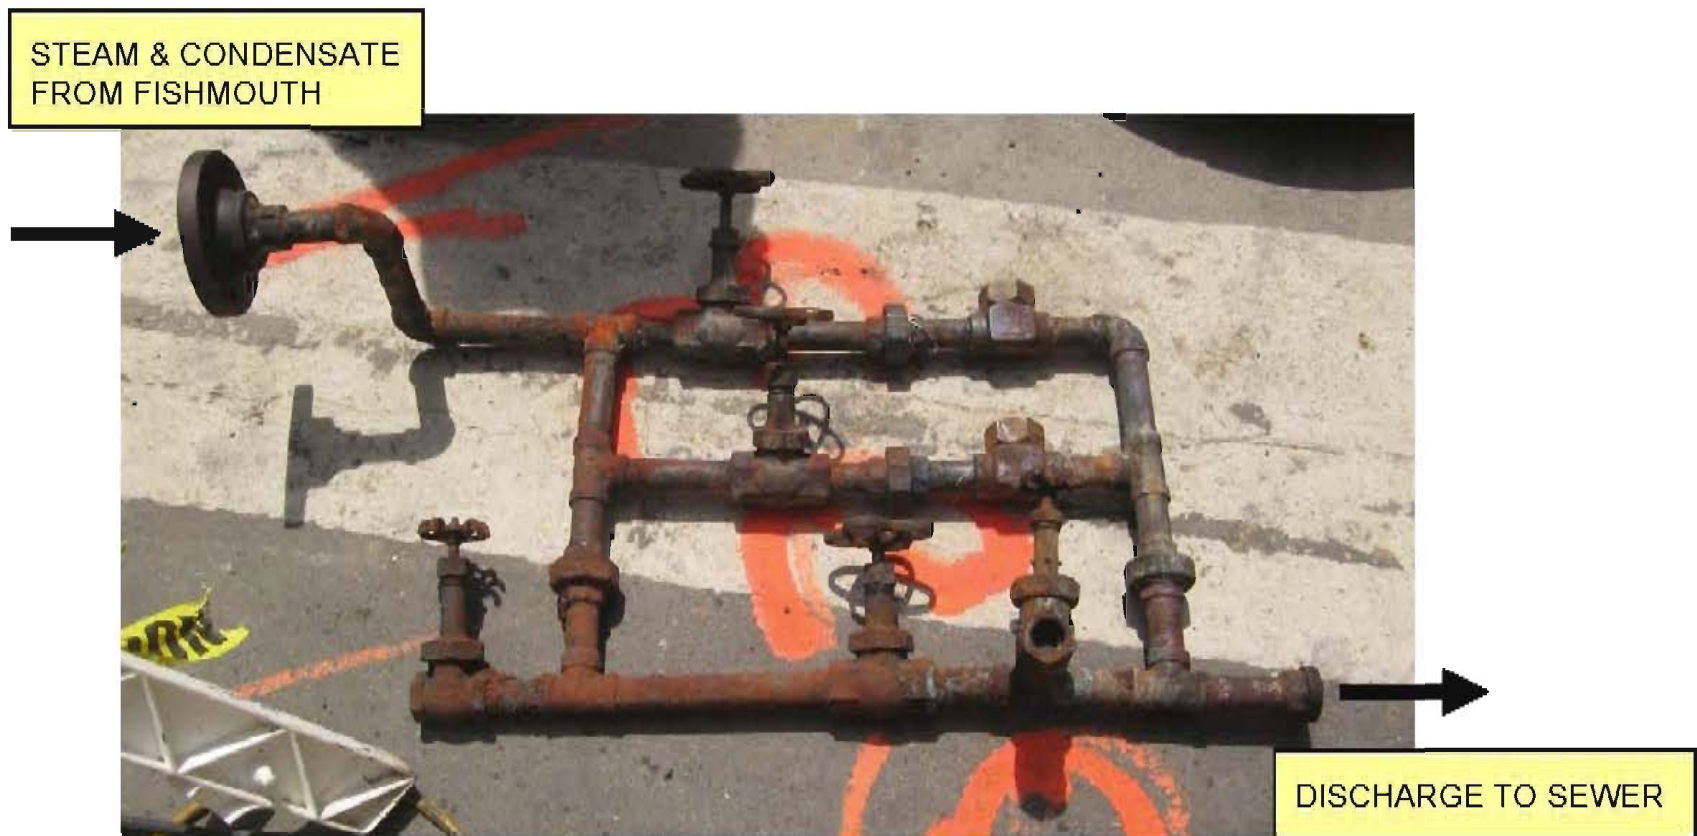
Figure 4-10: Steam Traps and Associated Piping Manifold Removed from Manhole # 7338 for Testing

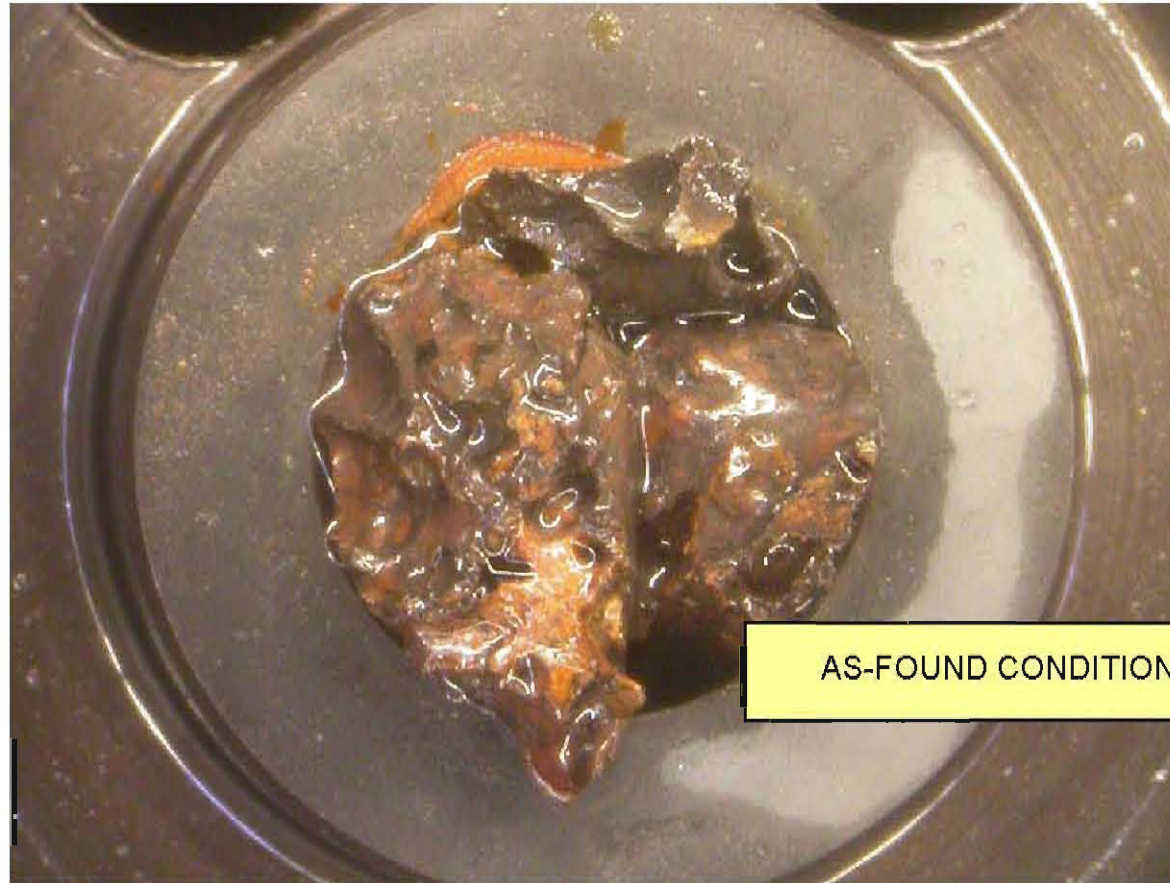
Both steam traps removed and examined after the event were substantially clogged with debris. This blockage reduced the traps' ability to remove condensate from the steam main. Debris material from one of the steam traps draining the pipe was identified as predominantly a Phenolic resin material with small quantities of iron oxide corrosion type products.

The debris found in the trap when the trap was opened was relatively tightly packed. This greatly limited the condensate flow that the traps would pass when tested. It is believed that the debris in the trap inlet port was in the trap prior to the waterhammer occurring. The waterhammer is a very short duration high intensity pressure pulse that would not move debris up the drain line. However, the drain line from the steam pipe all the way to the trap was water solid at the time of the waterhammer. This means that the pressure pulse of at least 1,060 psig would travel up the drain line to the trap. This would reach the debris in the inlet port and compact the material that had collected there. It is very likely that the appearance of tightly packed debris (see Figure 4-11) was an effect of the waterhammer occurrence.

Figure 4-11: As-found Condition of Upper Trap Following Cap Removal
(Lower trap had similar deposits, refer to [8])
